Global Marine Protection Services, Ltd.

Groyne and Breakwall Protection System

Pictures, from "Groyne Restoration Pilot Project" for the City of Sarnia, Ganatarra Park, January, 2008

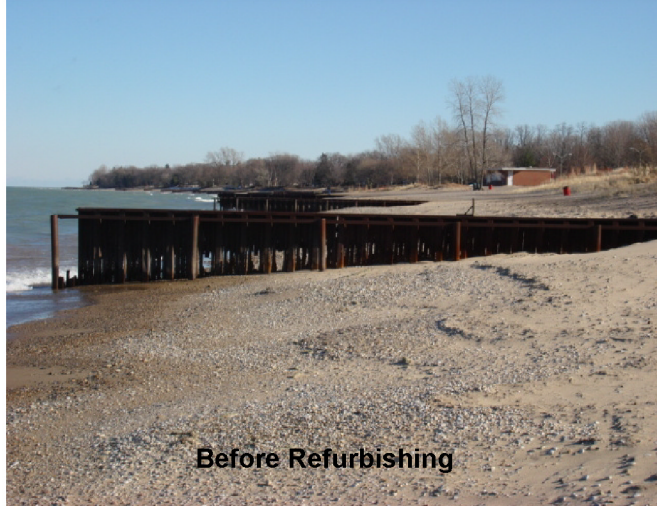
Before Refurbishing

One Case history is Sarnia's Canatara Park, which has several groynes that were installed in the early 1970s. Over the years, these groynes have deteriorated due to general erosion, ice and wave action, leaving jagged edges and gaping holes that allow the free flow of water, causing safety and aesthetic problems.

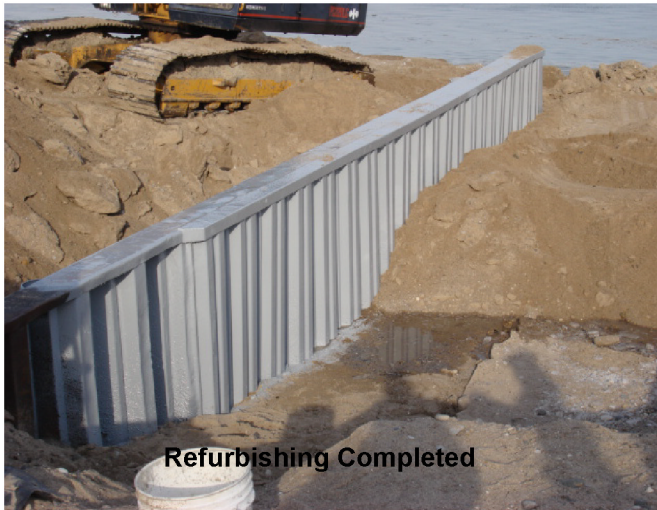
Refurbishing Completed

Application of the surface tolerant, environmentally friendly Cantex Coatings Ltd. Premier Rubber Membrane® (no VOCs) to a film build of 40 mils, with unlimited buildup potential in areas that are damaged and or dented, filling in seams and holes in the existing groyne/breakwall steel. The rusted old metal groynes and breakwall's now have a revitalized uniform appearance.

A top coat of a Hybrid Elastomeric Polyurethane (also an environmentally friendly coating with no VOCs) is then applied over the Rubber Membrane. The result is this very unique **Groyne and Breakwall,**
